Test Report

Sine Vibration Test For Agile 102

Customer Name: Mr Teoh Loo Chue
Product: Agile 102
Test Prime: Bernard Tan
Date Received: 26 November 2013
Date Perform: 27 November 2013
Report Number: QAV1213-1129
Test Location: 116, Lintang Kg Jawa, NFIZ3,
Taman Perindustrian Bayan Lepas,
Mk 12, 11900, Penang, Malaysia.

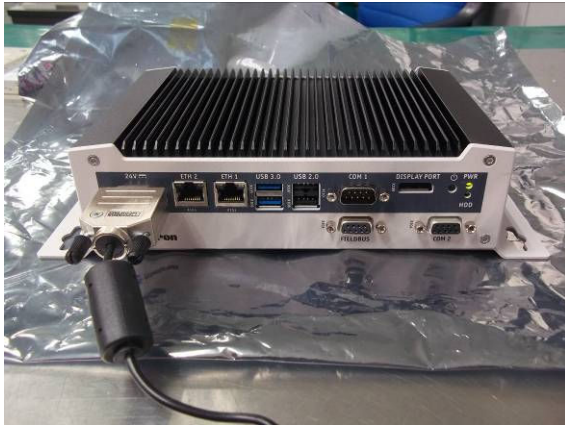
Picture 5: UUT After Test

Total 1 unit was subjected to vibration test. The unit was pass functional and visual check before and after the stress.
