Operating instructions for the baseboard ADA9

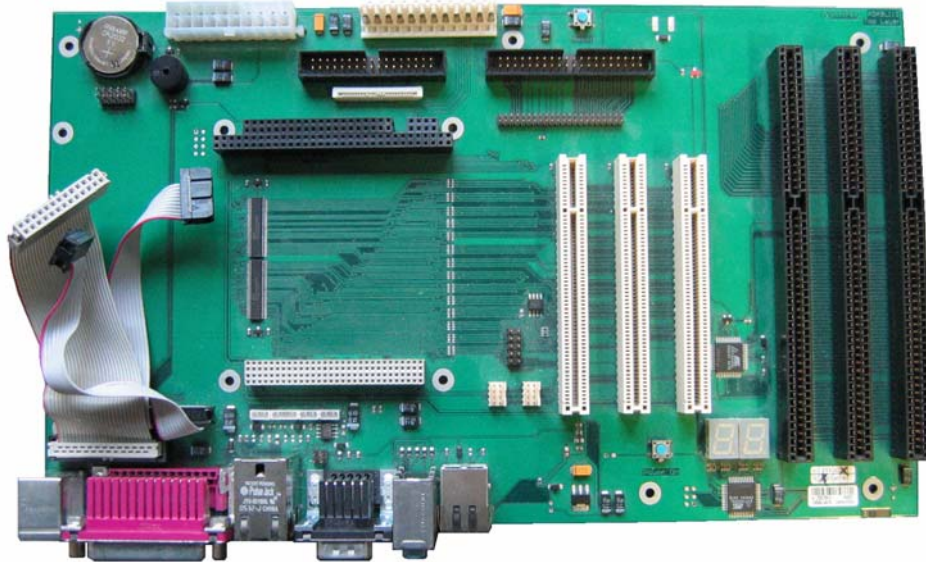
The cooperation between the MOPSIcdLX and the baseboard ADA9 causes an error in the LAN environment. The MOPSIcdLX owns a network transformer and the baseboard ADA9 owns a transformer (integrated within the connector).

The only way to bypass this issue is to use a separate cable adapter. An appropriate cable is available from KONTRON (KAB-MOPS-ETN1, part number 96048-0000-00-0).
