VM6050

CA.DT.A94.4e - March 2016

VM6050 Hardware Release Notes

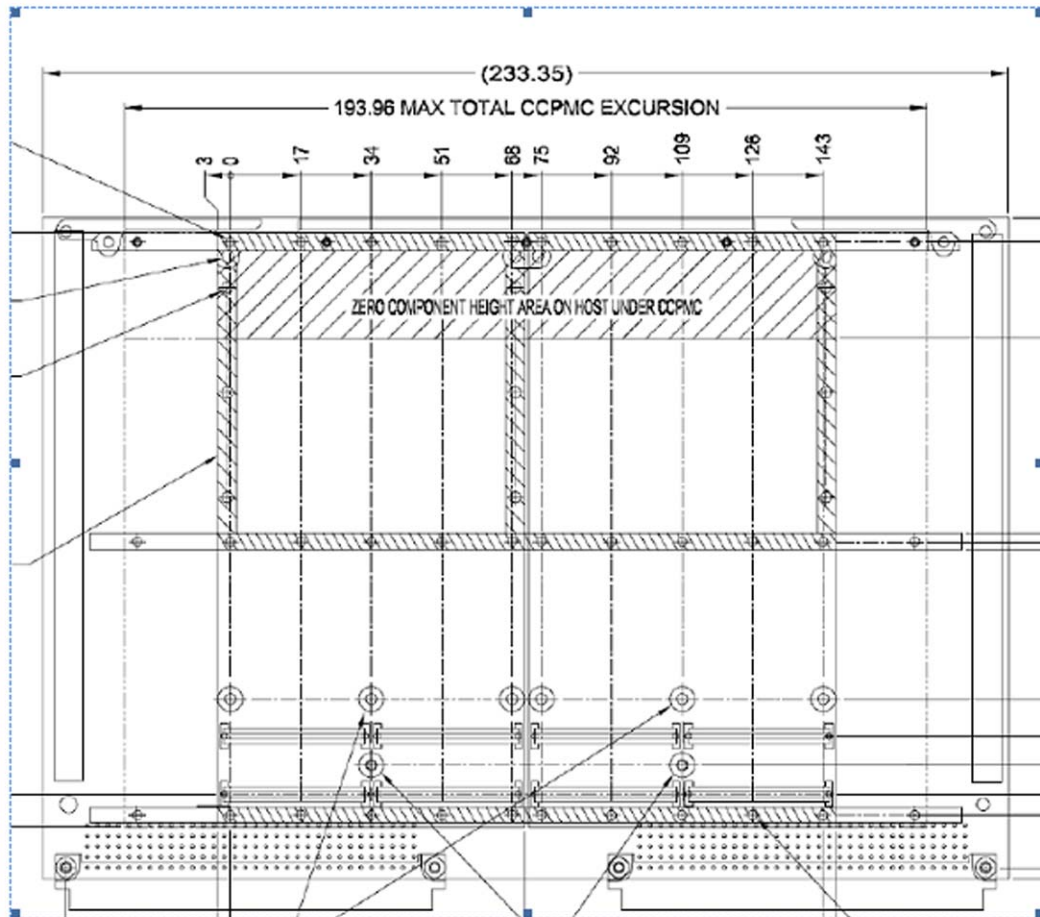
▶ PMC Excursion

PMC location does not satisfy the PMC excursion requirement in VITA 20 standard (see appendix) The distance from PMC edge to VM6050 edge size must be higher than 19.7 mm as specified by the VME standard. The actual size is 10.5 mm instead of the 19.7 mm, minimum that standard required.
