» VX304x «

## Hardware Release Notes

CA.DT.A99-2e - December 2014

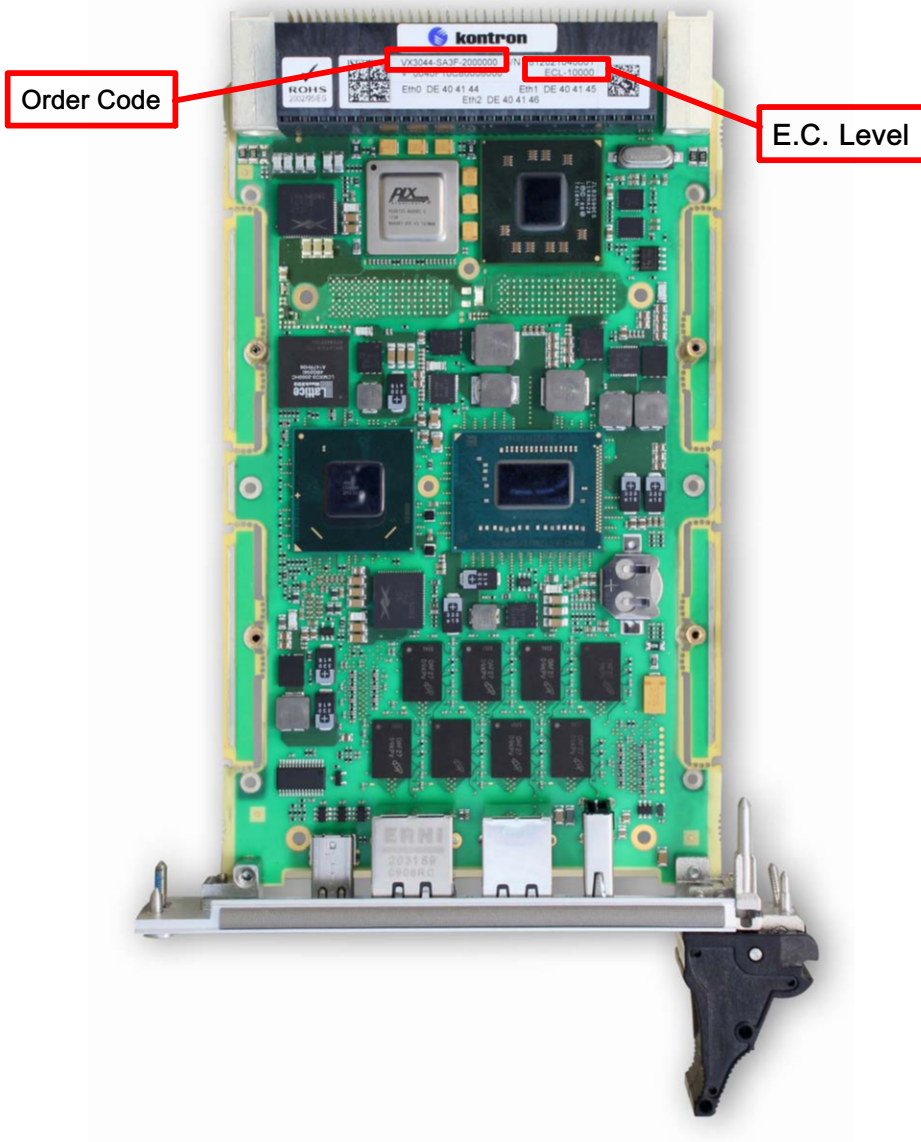
Figure 1: VX304x Identification

The Engineering Change Level (E.C. Level) and Order Code information are available on the "Board Identification" label, located on the top side of the board.

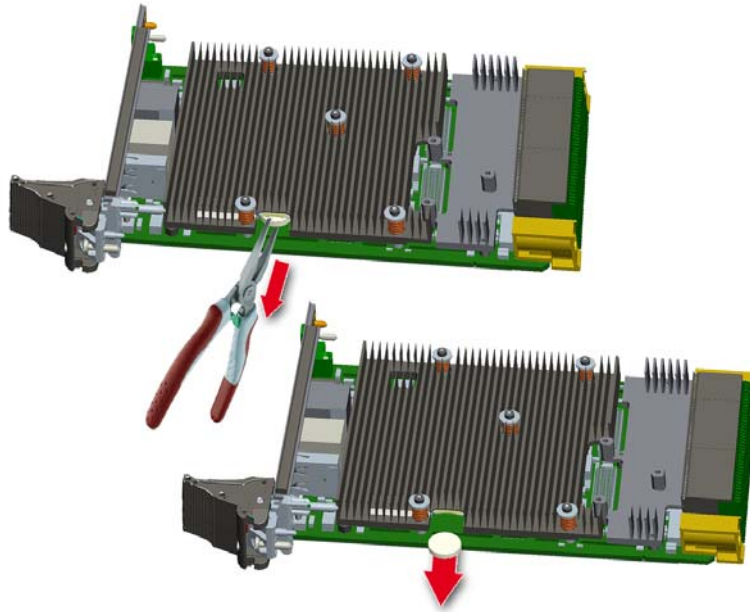
- > Turn off the power.
- > Get the battery outside of its holder:
  - ▶ on VX3040/SA boards with battery access on the side of the heatsink, by pulling it out with a small plier

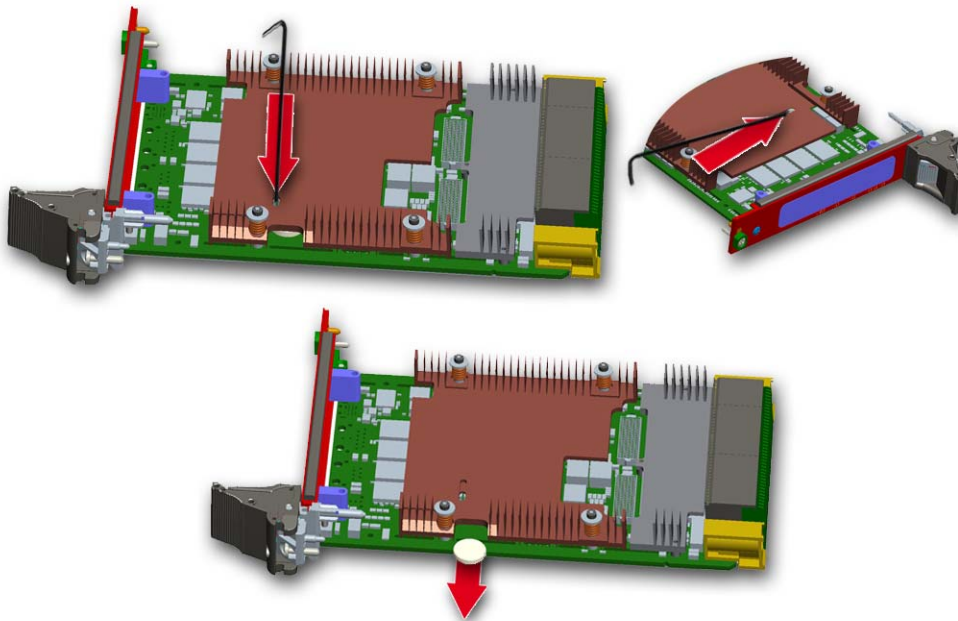
- ▶ on VX3040/SA boards with battery access through an opening in the heatsink, by pushing it out with an Allen key 1.5 mm (Farnell 1779098 or equivalent) or 1/16.

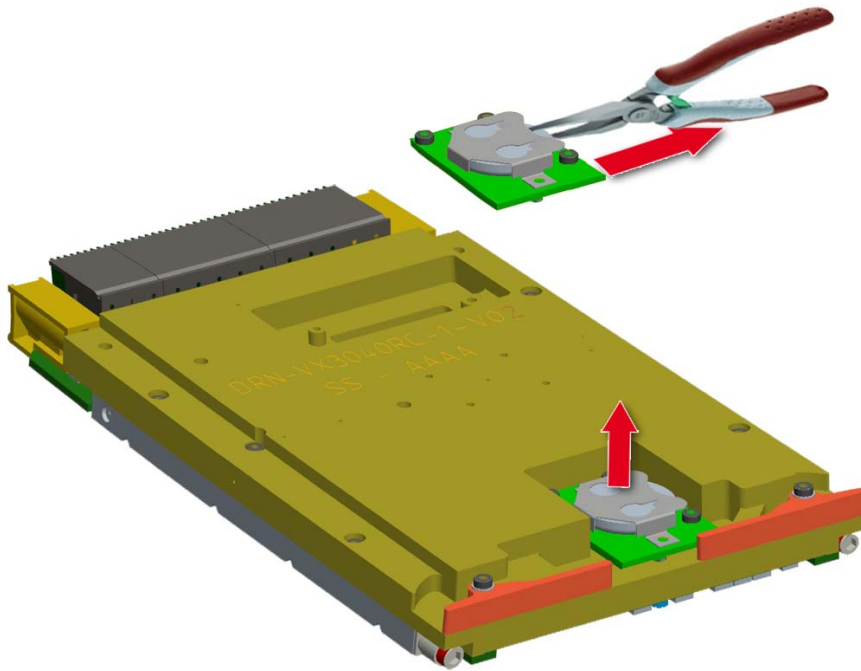
- ▶ on VX3040/RC boards with a battery mezzanine, by removing the mezzanine from the VX3040 board and pulling out the battery with a plier.
