# CG2400 SUP 16.00 (Software Update Package)

PCN no.: 2427

## 1/ Description of the change

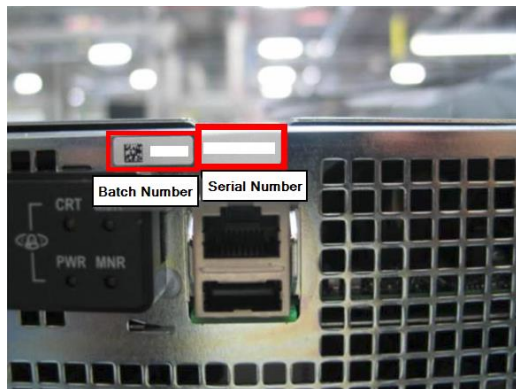
New production units of the CG2400 will not have the applied modification described herein. CG2400 with the batch ID number greater than 0100000008 will be setup with SUP09 unless specified by customer's contract. The batch ID number is indicated on a label next to the serial number label as illustrated below.

- Serial numbers can be verified using the BMC Web UI page or with IPMITOOL.
- Product's batch revision number can be identified through its product label, shown below.

Labels are located in this area.  
Exact placement varies according to the manufacturing date.
