ME1210 Foxglove (Software Update Package)

PCN no.: 2604

1. Description of the change

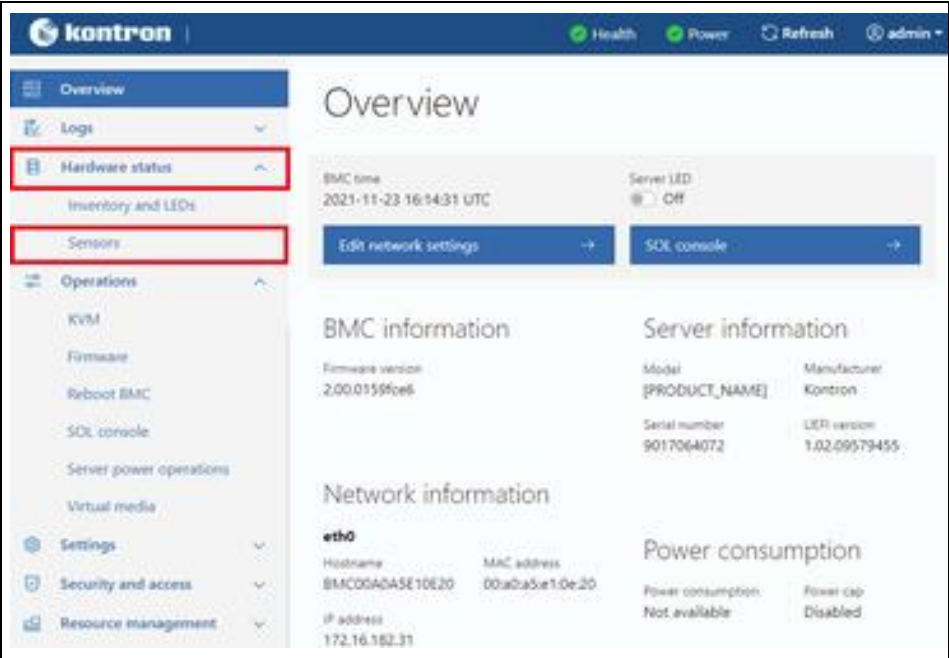
Step_1	<p>From the left-side menu of the BMC Web UI, click on Operations and then on Firmware.</p>

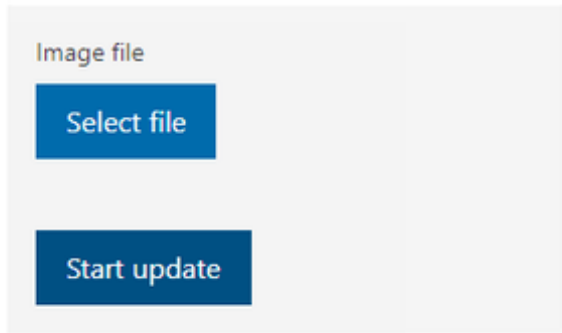
Step_3	From the Update firmware section , choose a .tar file to upload for the BMC by clicking on Select file .

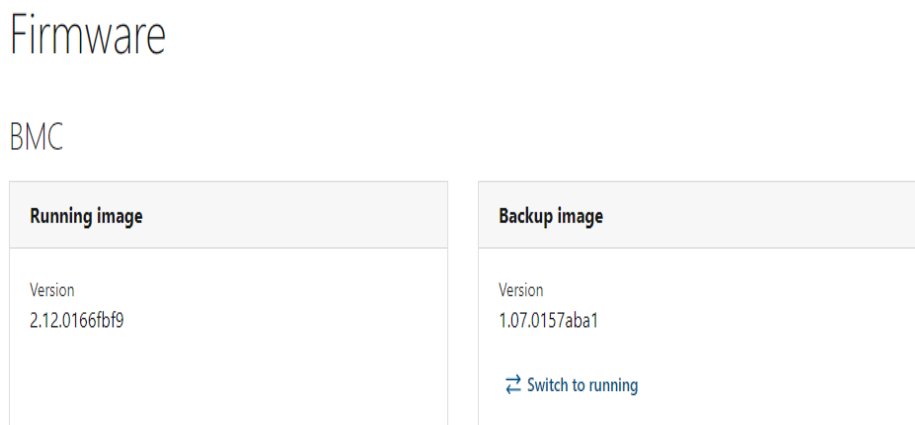
Step_4	Click on Start update .	
Step_5	When the file has successfully been uploaded, a success message should appear in the top right corner.	
Step_6	Wait for the BMC to update. The page should refresh automatically once the update succeeded.	
Step_7	Once the BMC becomes available again, verify that the firmware version has changed.

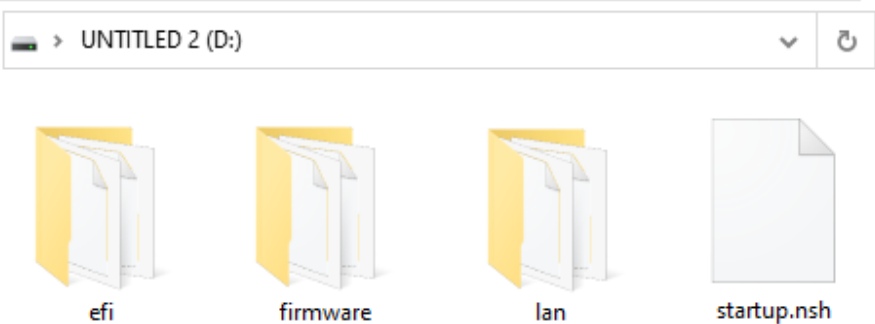
Step_1	<p>From another computer, extract the archive content provided by Kontron to a USB storage device. The startup.nsh file should be located directly in the root folder of the USB storage device.</p> <p>NOTE: Some of the archive content can change depending on the upgrade version.</p>

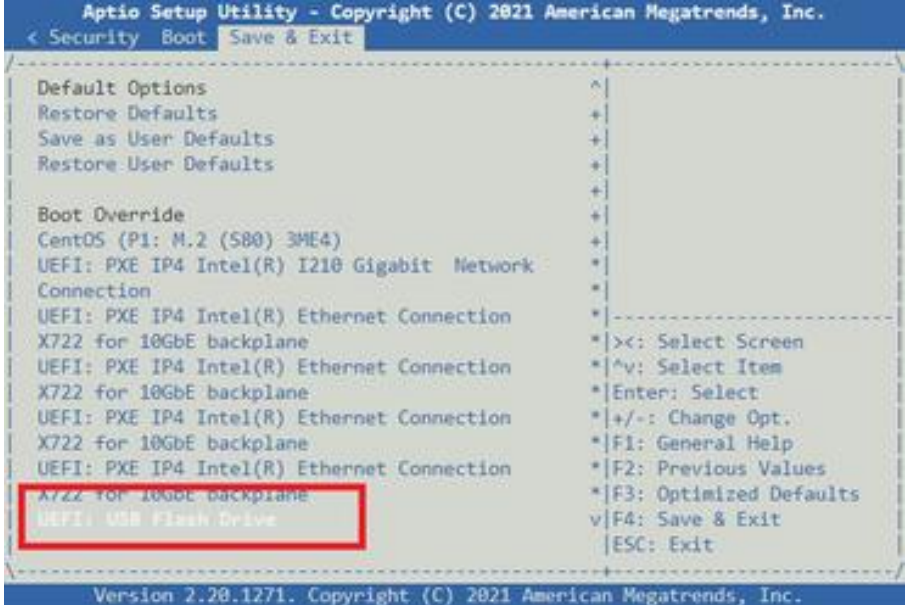
Step_4	<p>Navigate to the Save & Exit menu and then to the Boot Override section. Select the option that represents the USB storage device and press Enter.</p> <p>The built-in EFI Shell should launch.</p>

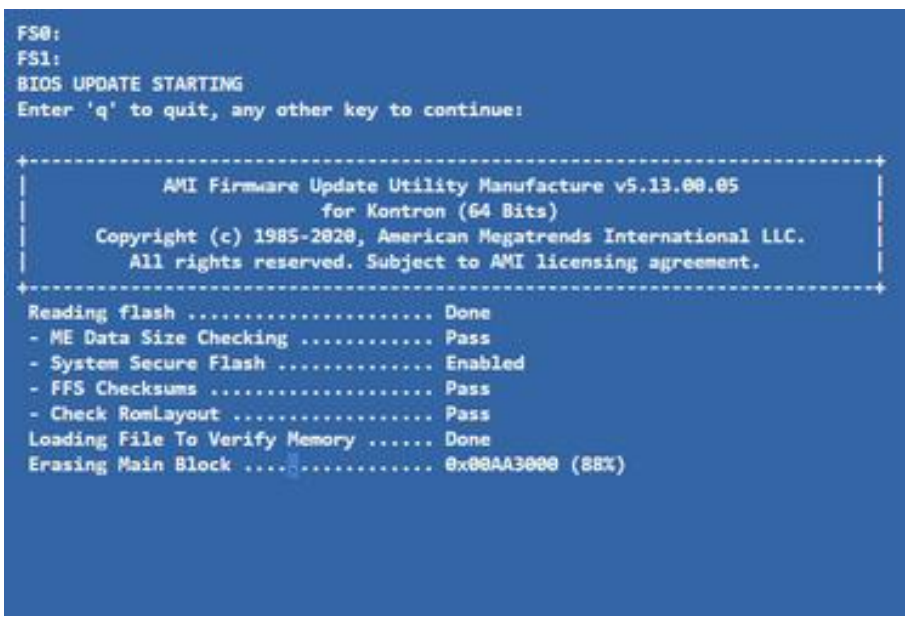
Step_5	<p>Press any key other than 'q' to continue. The UEFI/BIOS upgrade should start.</p>
