# ME1210 Edelweiss (Software Update Package)

PCN no.: 2525

## 1. Description of the change

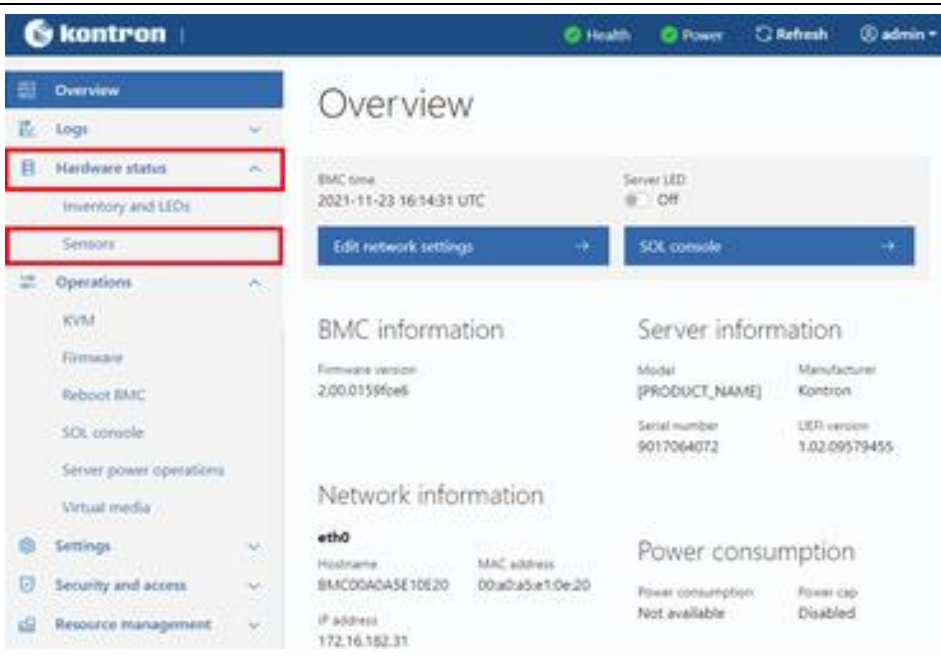
Step_1	From the left-side menu of the BMC Web UI, click on <b>Operations</b> and then on <b>Firmware</b> .

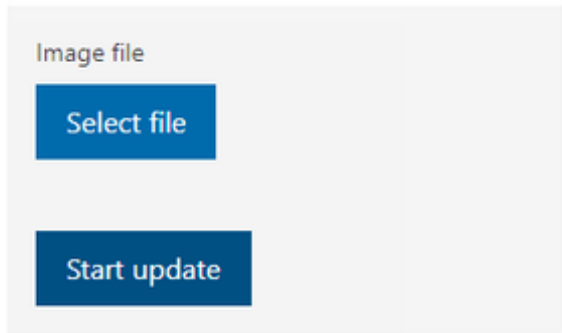
Step_3	From the <b>Update firmware</b> section , choose a <b>.tar</b> file to upload for the BMC by clicking on <b>Select file</b> .

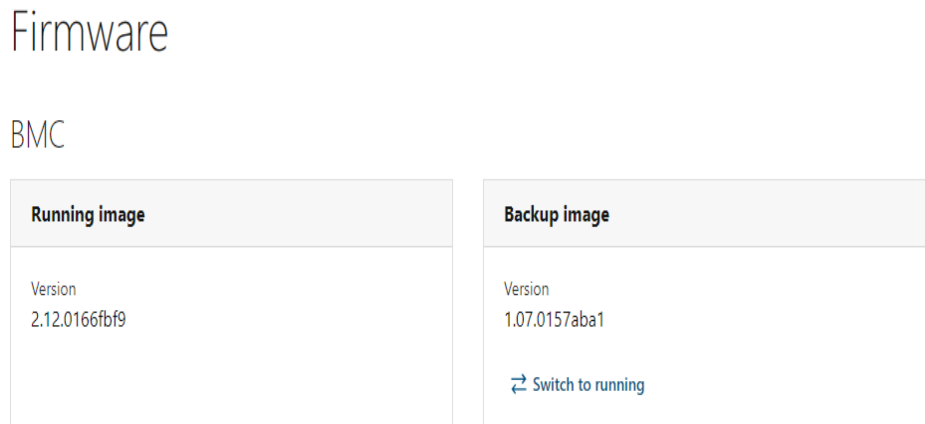
Step_4	Click on <b>Start update</b> .	
Step_5	When the file has successfully been uploaded, a success message should appear in the top right corner.	
Step_6	Wait for the BMC to update. The page should refresh automatically once the update succeeded.	
Step_7	Once the BMC becomes available again, verify that the firmware version has changed.

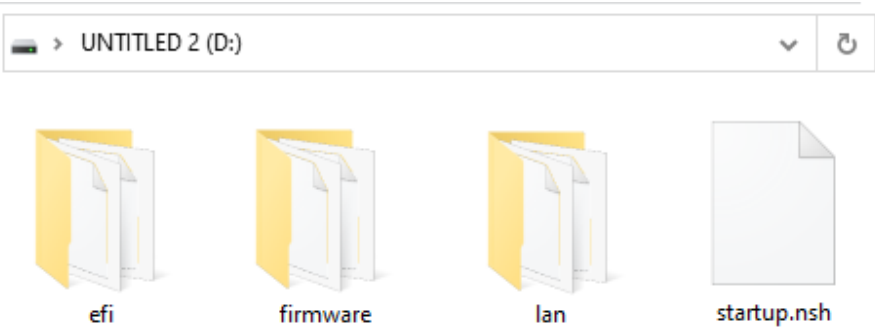
Step_1	<p>From another computer, extract the archive content provided by Kontron to a USB storage device. The <b>startup.nsh</b> file should be located directly in the root folder of the USB storage device.</p> <p><b>NOTE:</b> Some of the archive content can change depending on the upgrade version.</p>

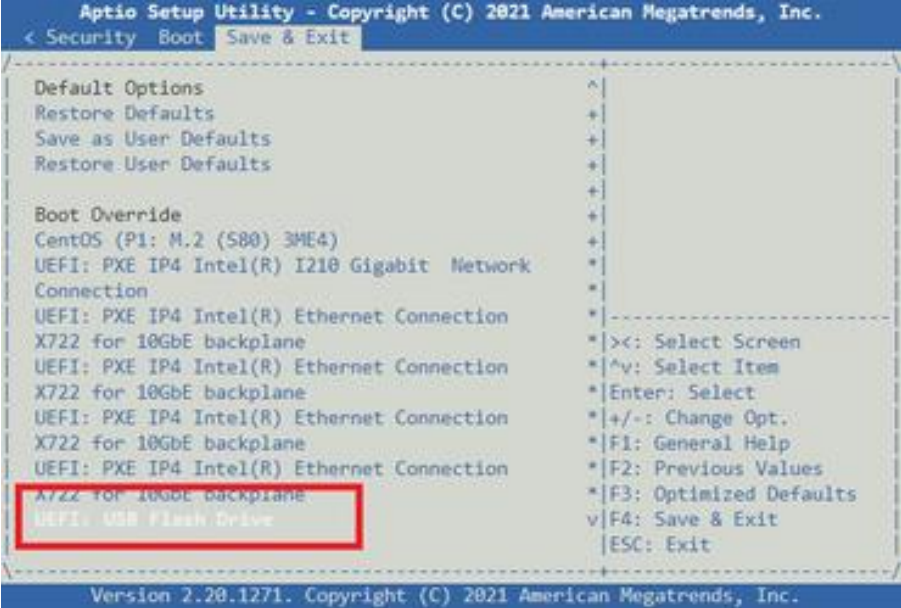
Step_4	<p>Navigate to the <b>Save &amp; Exit</b> menu and then to the <b>Boot Override</b> section. Select the option that represents the USB storage device and press <b>Enter</b>.</p> <p>The built-in EFI Shell should launch.</p>

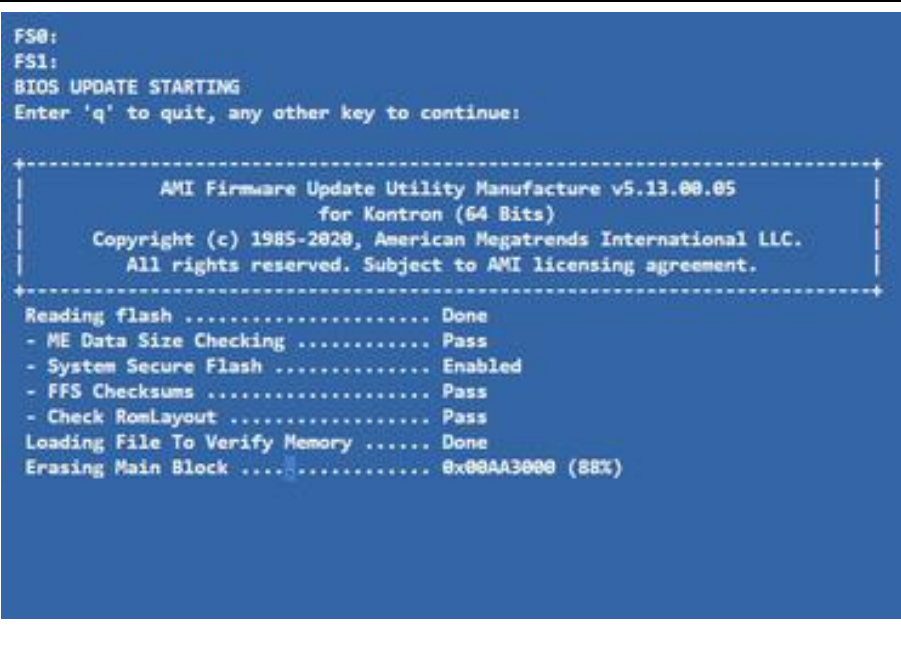
Step_5	<p>Press any key other than 'q' to continue. The UEFI/BIOS upgrade should start.</p>
