ME1310

(Software Update Package)

PCN no.: 2611

This PCN includes firmware modifications contributing to the fix of multiple issues and added improvements for the BMC.

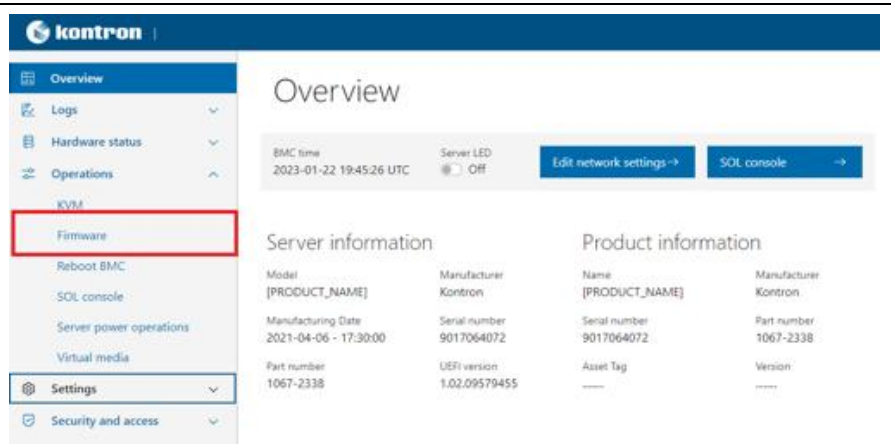
Step_1	<p>From the left-side menu of the BMC Web UI, click on Operations and then on Firmware.</p>

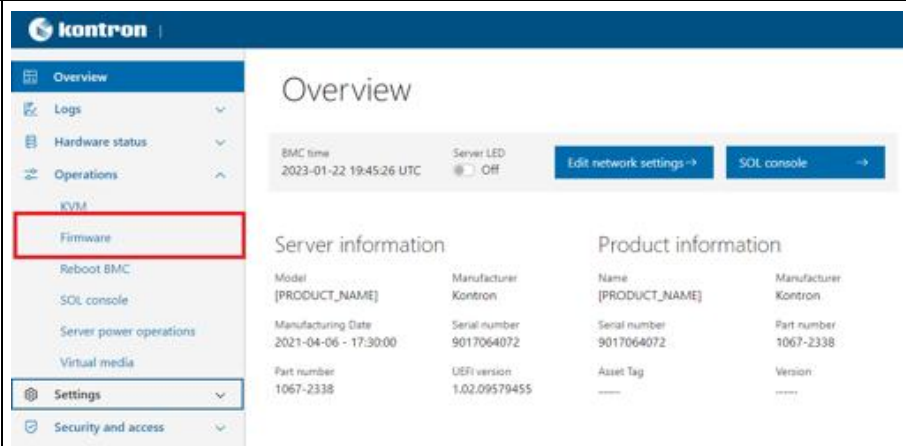
Step_1	<p>From the left-side menu of the BMC Web UI, click on Operations and then on Firmware.</p>

<p>The screenshot shows the Kontron BMC Web UI. On the left, a sidebar menu has 'Operations' expanded, and 'Firmware' is highlighted with a red box. The main content area is titled 'Overview' and displays server information (Model, Manufacturer, Manufacturing Date, Part number) and product information (Name, Manufacturer, Serial number, Part number, Asset Tag, Version). Buttons for 'Edit network settings' and 'SOL console' are visible.</p>
--------	---	--

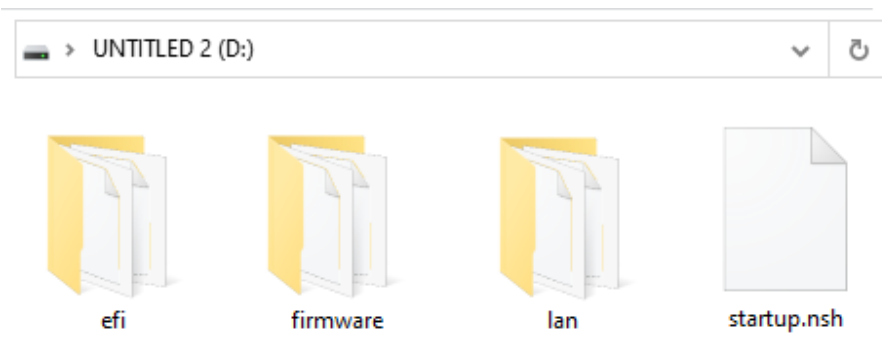
Step_1	<p>From another computer, extract the archive content provided by Kontron to a USB storage device. The startup.nsh file should be located directly in the root folder of the USB storage device.</p> <p>NOTE: Some of the archive content can change depending on the upgrade version.</p>

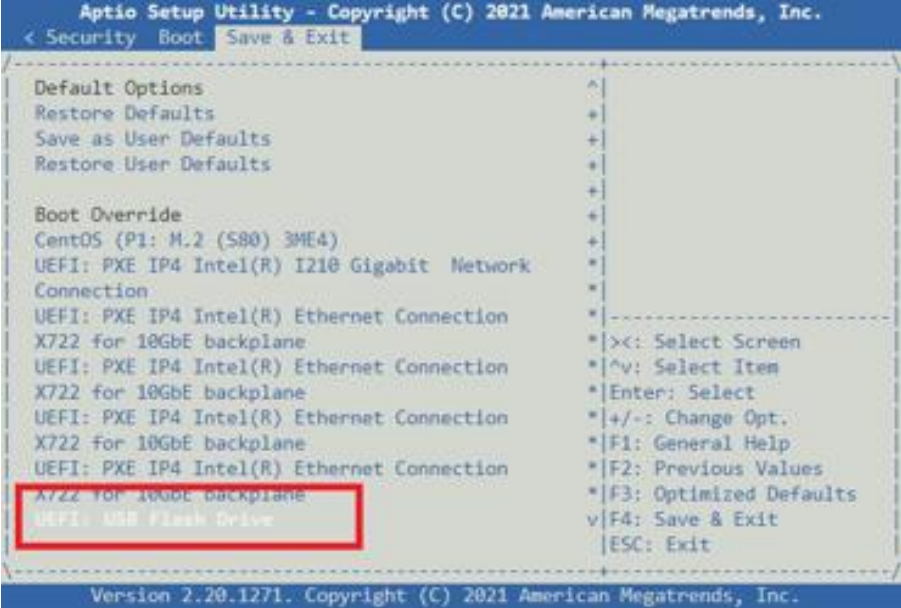
Step_4	<p>Navigate to the Save & Exit menu and then to the Boot Override section. Select the option that represents the USB storage device and press Enter.</p> <p>The built-in EFI Shell should launch.</p>

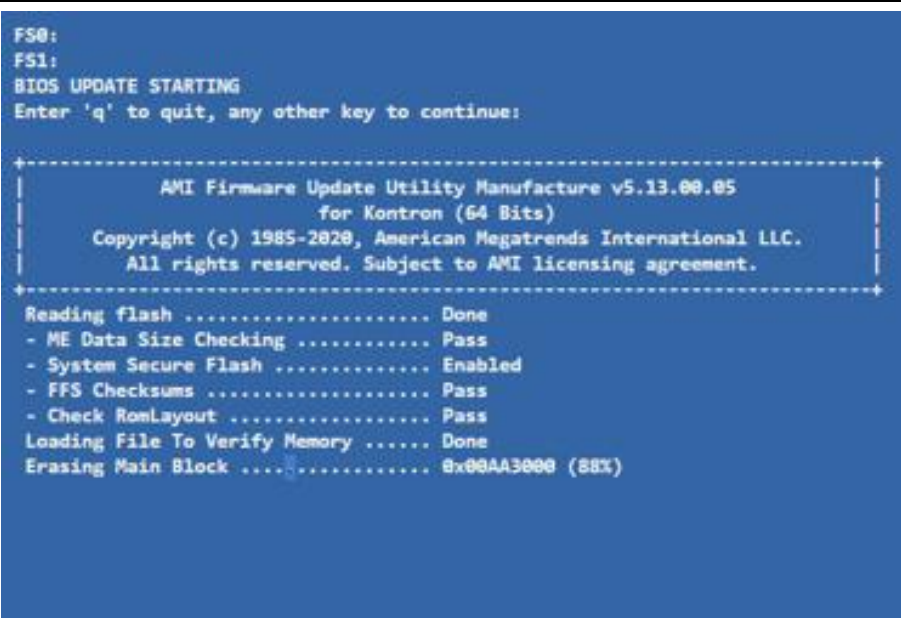
Step_5	<p>Press any key other than 'q' to continue. The UEFI/BIOS upgrade should start.</p>

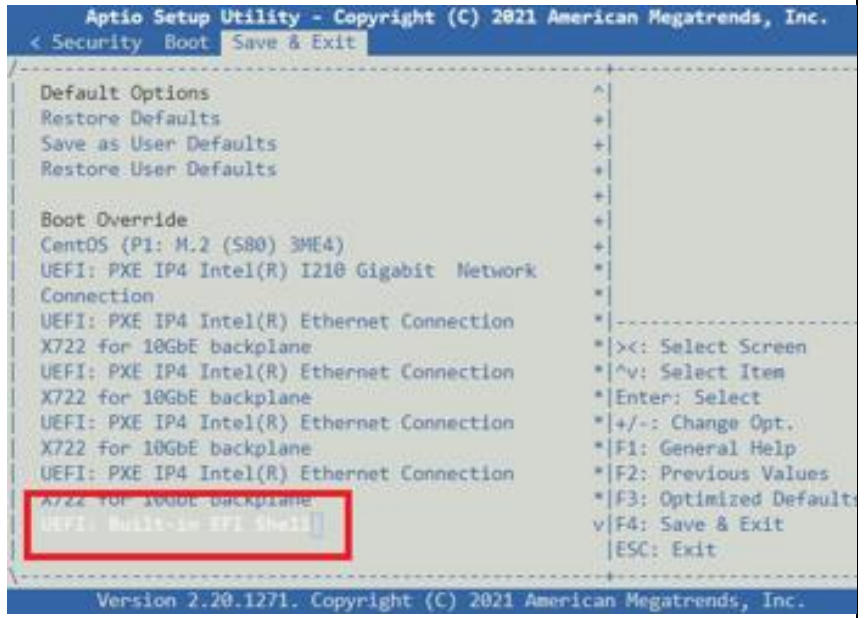
Step_1	Power on the platform or reboot the integrated server. Access the operating system.	
Step_2	Once the archive is downloaded to the platform, extract the archive content provided by Kontron on the Linux OS installed on the platform.	
Step_3	Copy the content of the archive to the /boot/efi directory. LocalServer_OSPrompt:~# cp -a [PATH_TO_ARCHIVE]/. /boot/efi/	<pre>[root@localhost ~]# cp -a /home/archive/. /boot/efi/</pre>
Step_4	Verify that the startup.nsh script can be found directly in the /boot/efi directory. LocalServer_OSPrompt:~# ls /boot/efi NOTE: Some of the content of the archive could change depending on the version.	<pre>[root@localhost ~]# ls /boot/efi EFI firmware lan startup.nsh</pre>
Step_5	Reboot the platform and access the UEFI/BIOS setup menu.	
Step_6	Navigate to the Save & Exit menu and then to the Boot Override section. Select the option that corresponds to the UEFI: Built-in EFI Shell and press Enter . The built-in EFI Shell should launch.

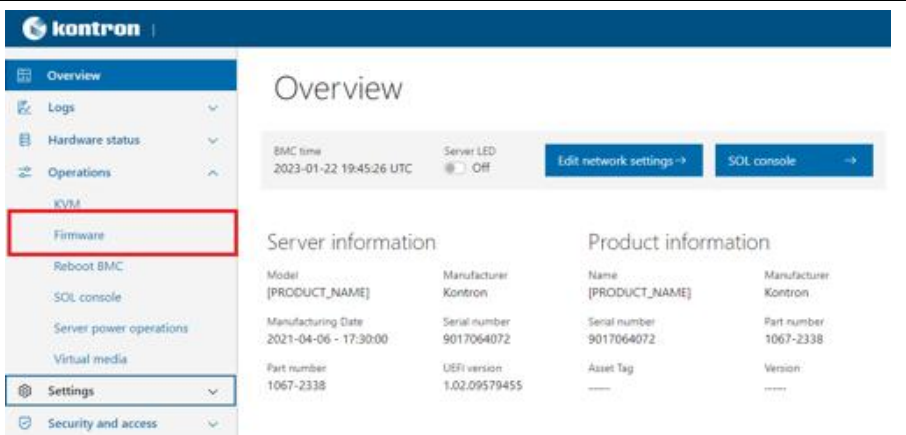
Step_1	From the left-side menu of the BMC Web UI, click on Operations and then on Firmware .

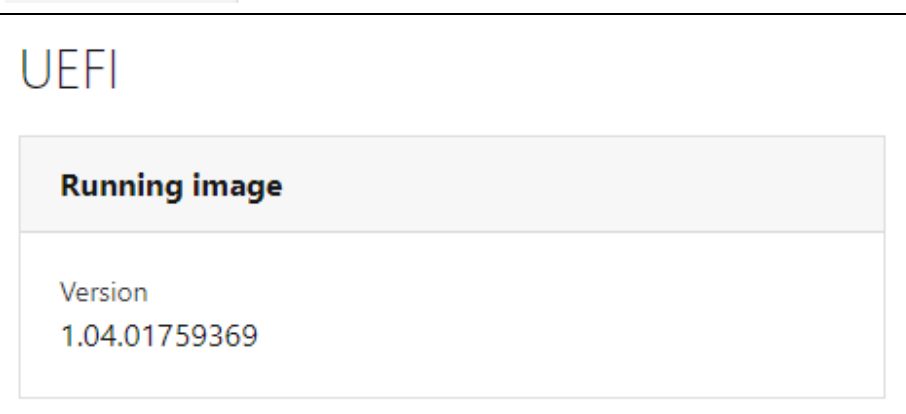
Step_2	Verify the current firmware version. Make sure that the new firmware is more recent.

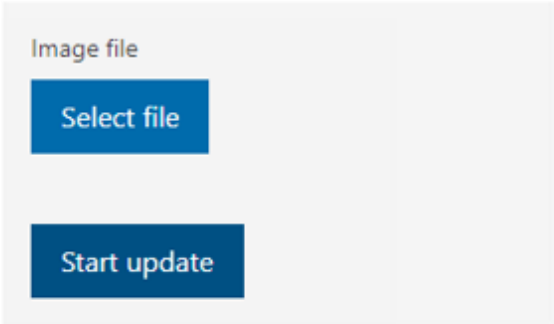
Step_3	From the Update firmware section, choose a .tar.gz file to upload for the UEFI/BIOS by clicking on Select file .
