# ME1210/ME1310 NOS 2.50 (NOS firmware update)

PCN no.: 2412

## 1/ Description of the change

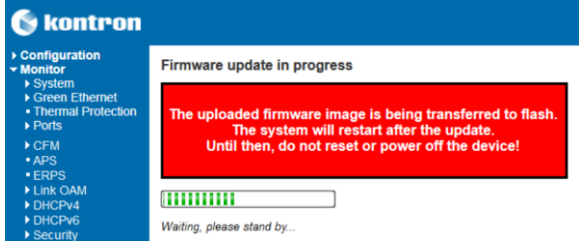
<p>(captured image is with a previous FW version)</p>
Step_4	Wait for the upload and upgrade process to complete.

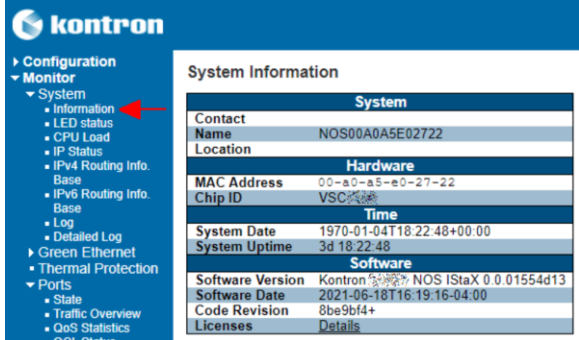
Step_5	Once the upgrade is done, from the left-side menu, select <b>Monitor, System</b> and then <b>Information</b> . Confirm that the <b>Software Version</b> corresponds to that of the <b>.itb</b> file.

<p>(captured image is with a previous FW version)</p>
